Re: Monthly Report Summary #19 for the South Orange County Reliability Enhancement (SOCRE) Project

South Orange County Reliability Enhancement Project CPUC Site Inspection Form

Project:	South Orange County Reliability Enhancement (SOCRE) Project	Date:	May 7, 2019
Project Proponent:	San Diego Gas & Electric (SDG&E)	Report #:	VS032
Lead Agency:	California Public Utilities Commission (CPUC)	Monitor(s):	CPUC/Ecology and Environment (E & E) Compliance Monitor
CPUC PM:	Andrew Barnsdale, Energy Division	AM/PM Weather:	Overcast with slight drizzle, cool and breezy
CPUC CM (E & E):	Joe Donaldson	Start/End Time:	0730 to 0830
Project NTP(s):	NTP-1, NTP-2, NTP-2 Addendum 1, NTP-3, and NTP-4

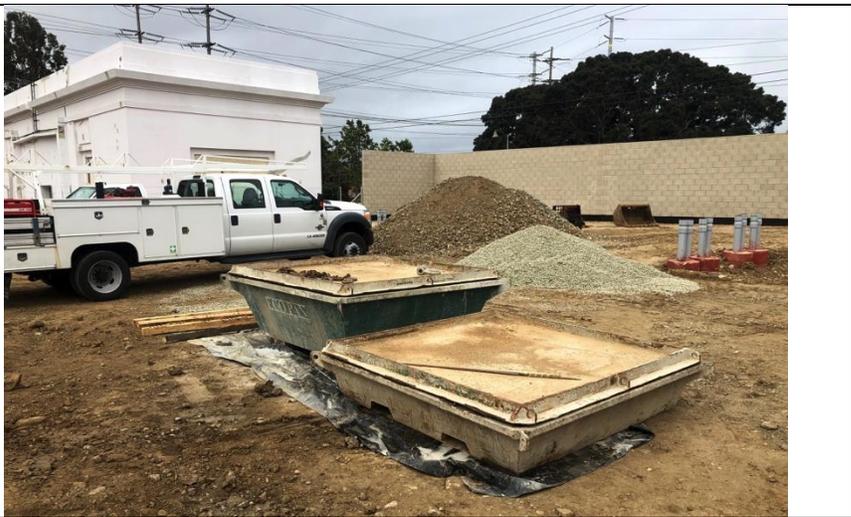
Two concrete washout bins located near the western wall were well contained (Photo 1). The SDG&E Environmental Coordinator said 15 concrete trucks were onsite the day prior to my site visit to pour a portion of the 138-kilovolt (kV) gas-insulated substation (GIS) building retaining wall foundation (Photo 2). Also on the prior day, crews used sweeper trucks to clean the public roadway because the site received a small amount of rain. The crews continued to use sweeper trucks to clean the roads on the day of my site visit.

Photo 1 – Concrete washout bins. Photo facing southwest.
5/07/19	San Juan Capistrano Substation

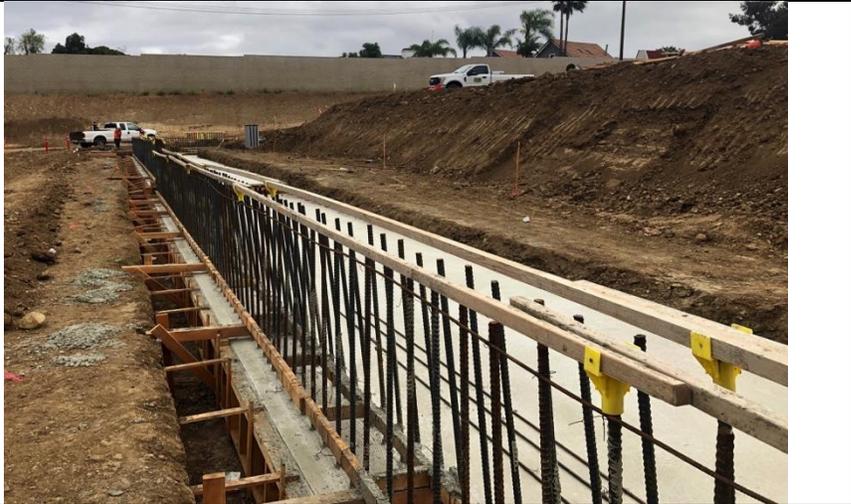
Photo 2 – Foundation for the 138 kV GIS building. Photo facing north.
5/07/19	San Juan Capistrano Substation

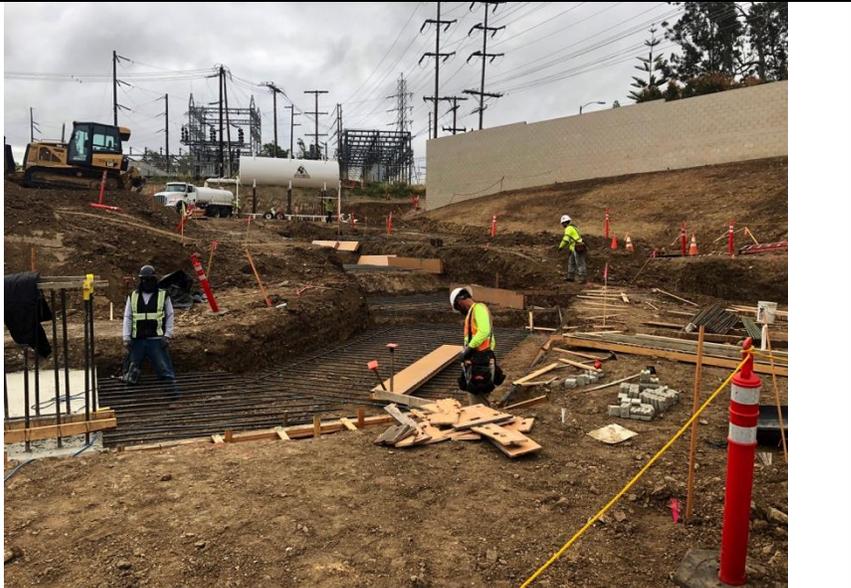
Photo 3 – Rebar and form work for the southern portion of the retaining wall foundation. Photo facing east.

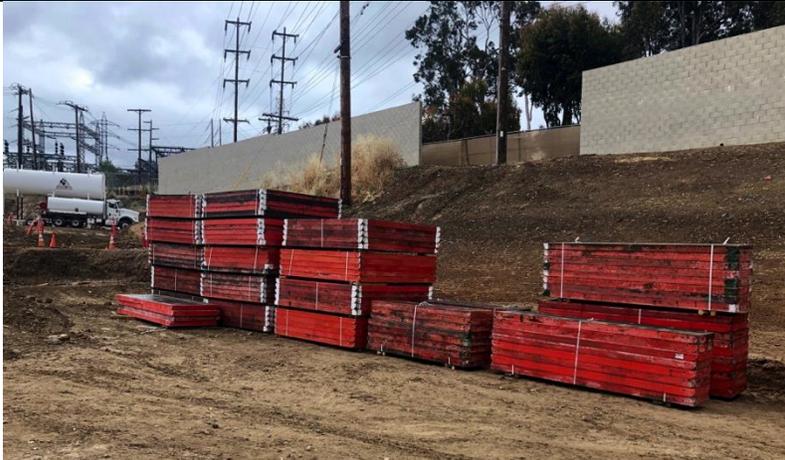
Photo 4 – Concrete forms staged at the San Juan Capistrano Substation site. Photo facing southeast.
5/07/19	San Juan Capistrano Substation

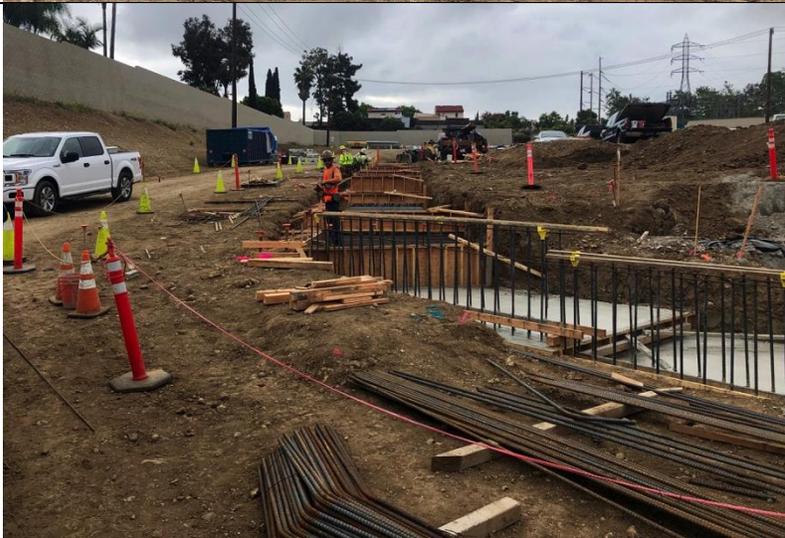
Photo 5 – Rebar and form work for the northern portion of the retaining wall foundation. Photo facing east.
5/07/19	San Juan Capistrano Substation

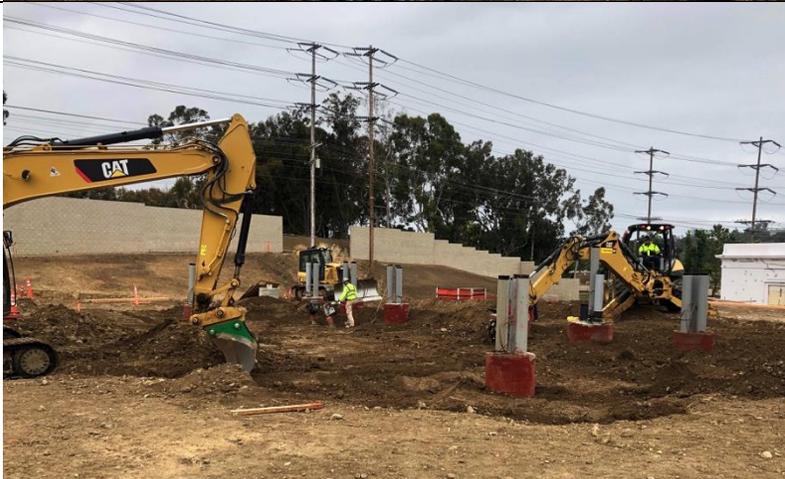
Earthwork was occurring around the conduit that emerges within the 138 kV GIS building footprint. An excavator, bulldozer, and backhoe were being used to excavate and compact soil around the conduit pipe (Photo 6). A water truck was being used at this location to spray the soil to suppress dust and provide moisture for proper soil compaction (Photo 7).

Photo 6 – Earthwork around the conduit pipe. Photo facing southwest.

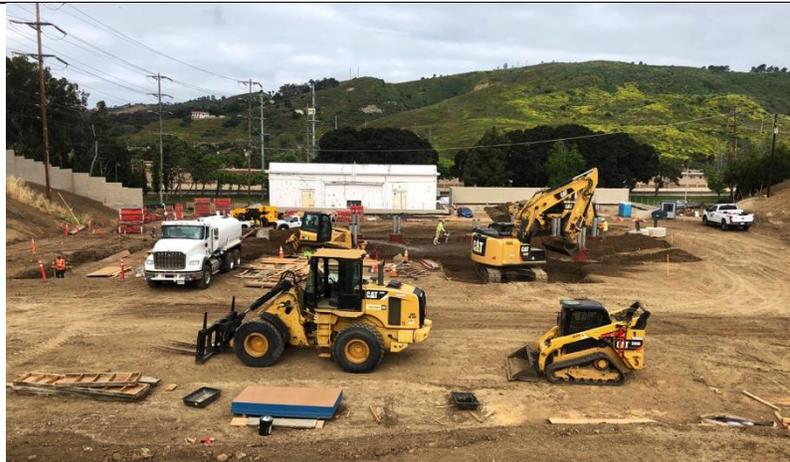
Photo 7 – Earthwork occurring at the San Juan Capistrano Substation site. Photo facing west.
5/07/19	San Juan Capistrano Substation

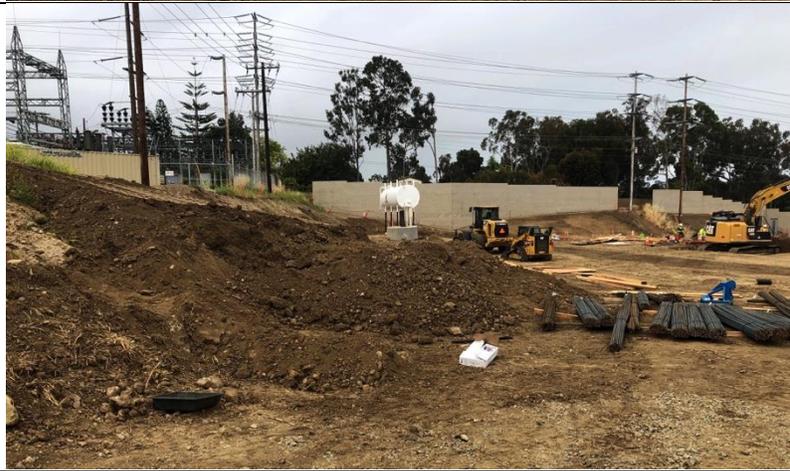
Photo 8 – Stockpiled soil at the San Juan Capistrano Substation site. Photo facing south.

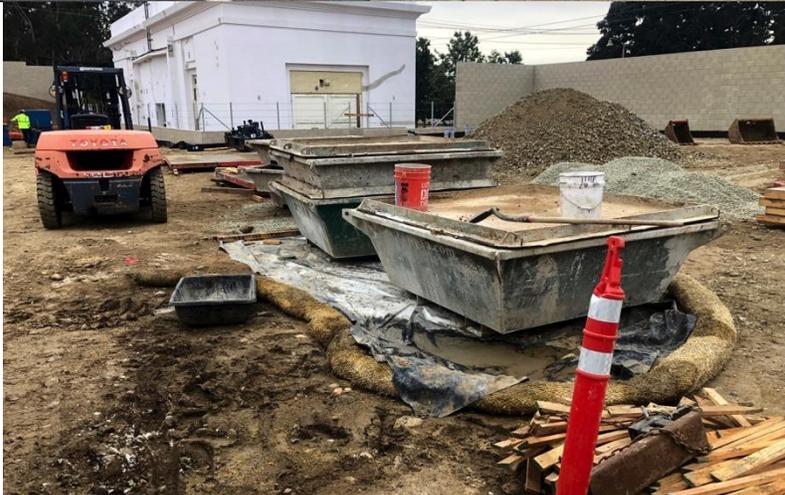
On the day prior to my site visit, 15 trucks had been onsite at the San Juan Capistrano Substation site for a major concrete pour. The concrete washout bins were well contained but appeared somewhat worn (Photo 2); however, they were providing sufficient containment. The concrete pour that occurred the prior day finished the southern and northern portions of the retaining wall foundation for the 138-kilovolt (kV) gas-insulated substation (GIS) building (Photos 3 & 4). On the day of my site visit, construction crews were beginning to strip the forms off of the concrete. Steel forms were being set up for the retaining wall along the western edge of the building pad (Photo 5).

Photo 2 – Concrete washout bins. Photo facing south.
5/15/19	San Juan Capistrano Substation

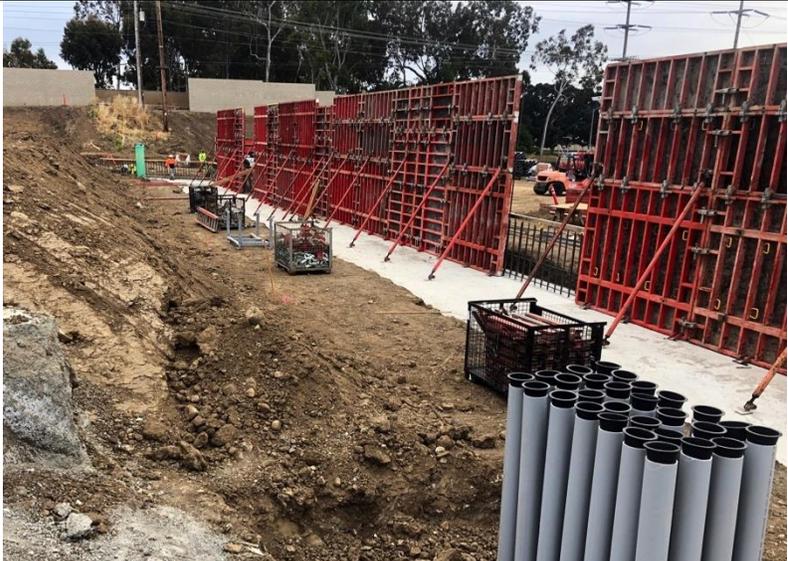
Photo 5 – Form work for the western portion of the retaining wall. Photo facing south.

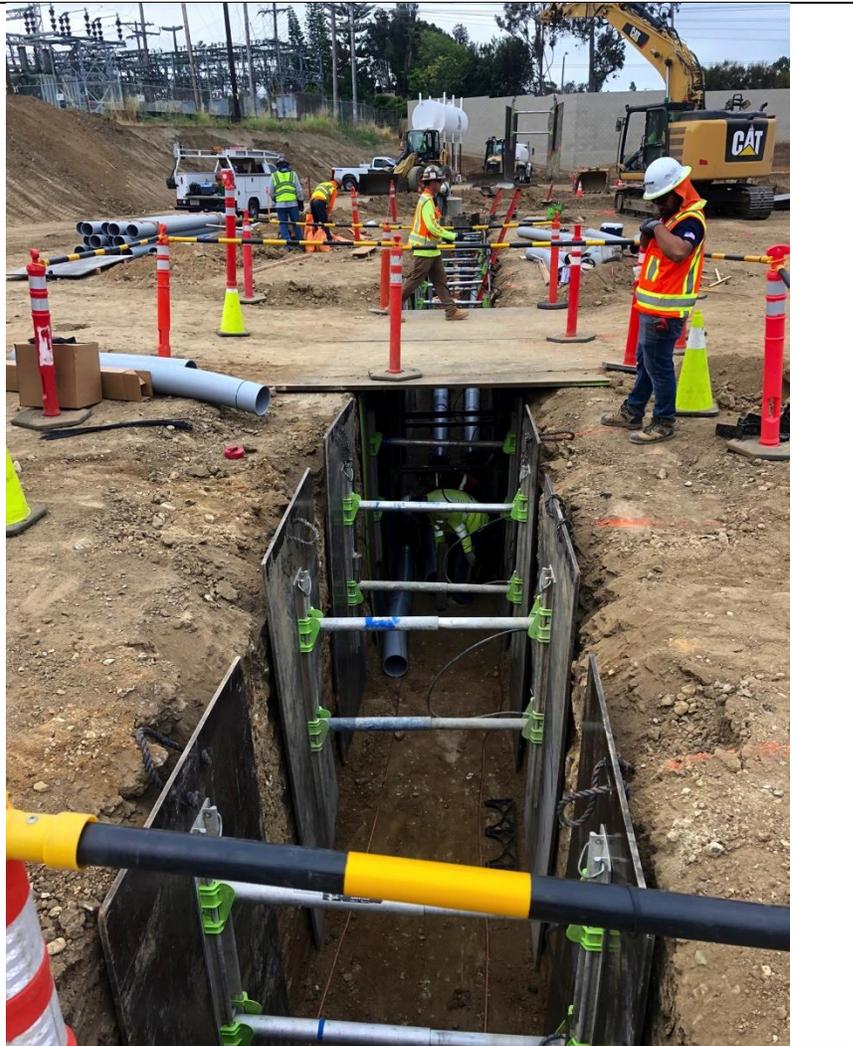
Conduit installation continued within the 138 kV GIS building pad; construction crews were working in a deep, well-shored trench (Photo 6). Several small areas of conduit trench were still open, with the conduit adequately capped (Photo 7). I observed that one of the conduit trenches contained a board for an escape ramp for wildlife, but the other conduit trench did not have any escape ramp. The SDG&E representative and I spoke about the lack of an escape ramp, and I recommended an escape ramp be provided for this conduit trench.

Photo 6 – Conduit installation. Photo facing south.
5/15/19	San Juan Capistrano Substation

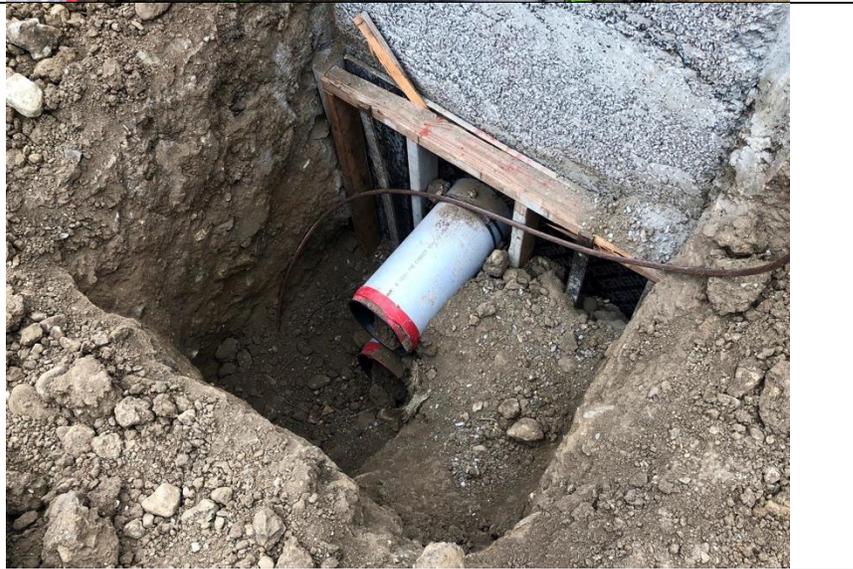
Photo 7 – Capped conduit in a trench.

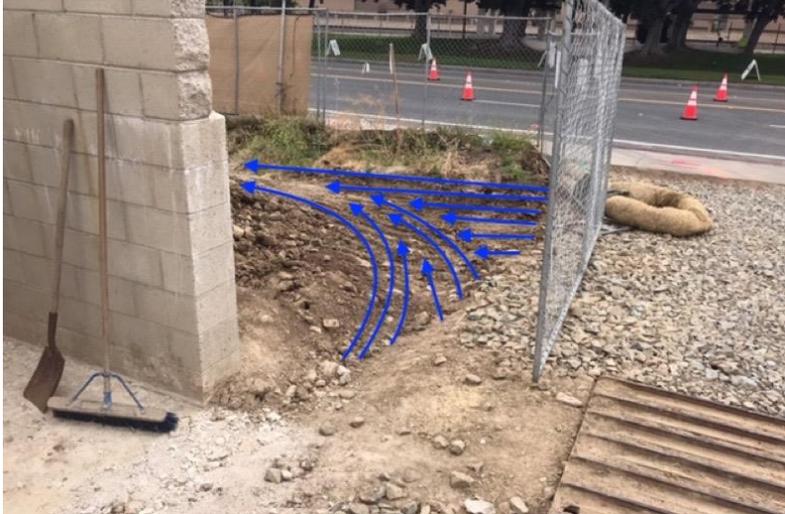
Photo 9 – Rainwater runoff diversion adjacent to the northern entrance. Photo facing west (Photo provided by the SDG&E Environmental Coordinator).
5/15/19	San Juan Capistrano Substation

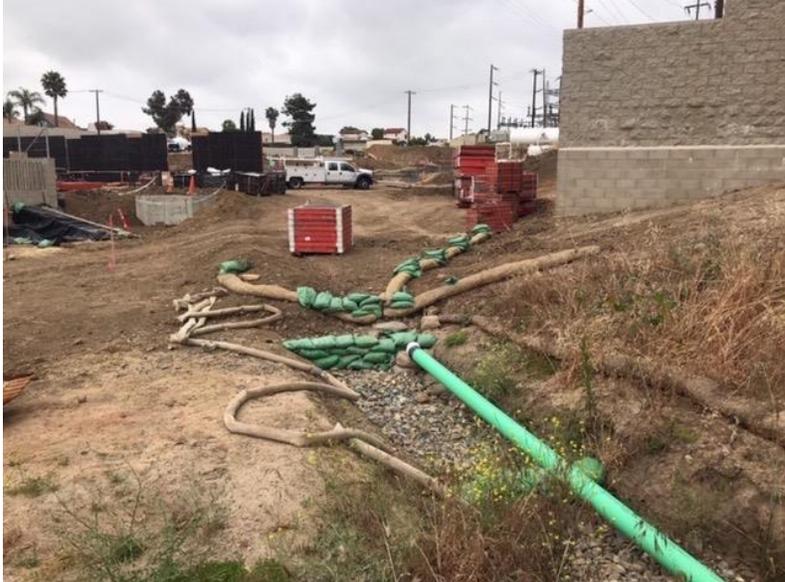
Photo 10 – Upgraded BMPs near the southern entrance sediment basin. Photo facing east (Photo provided by SDG&E Environmental Coordinator).

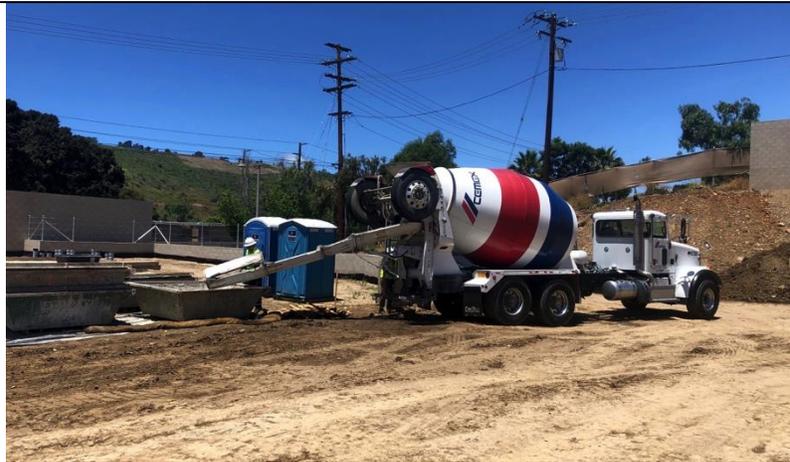
Concrete trucks were being used to finish pouring one of the conduit trenches, and a crew was washing out the last concrete truck at the designated location (Photo 2). Black plastic drip pans had been placed under engines and were being used to contain a gasoline can (Photo 4). The drip pan used to contain the gasoline can appeared somewhat worn but was still providing adequate containment.

Photo 2 – Concrete washout. Photo facing northwest.
5/20/19	San Juan Capistrano Substation

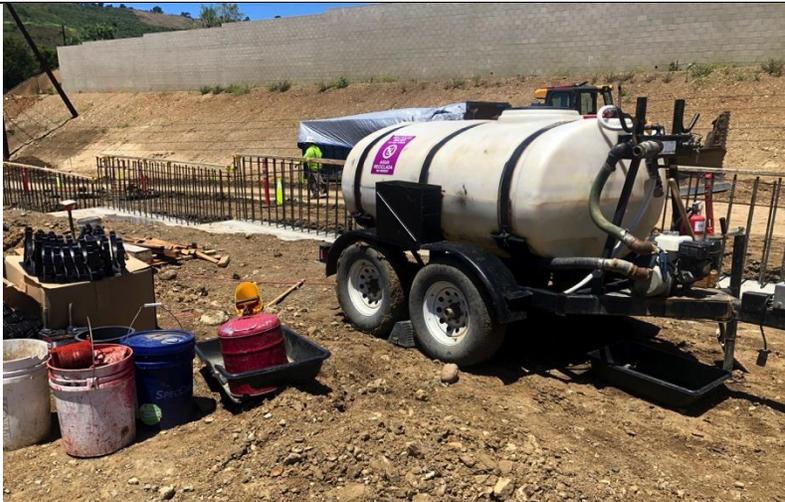
Photo 4 – Drip pans in place. Photo facing northwest.
5/20/19	San Juan Capistrano Substation

Clean out the drip pans and replace worn drip pans with new ones.

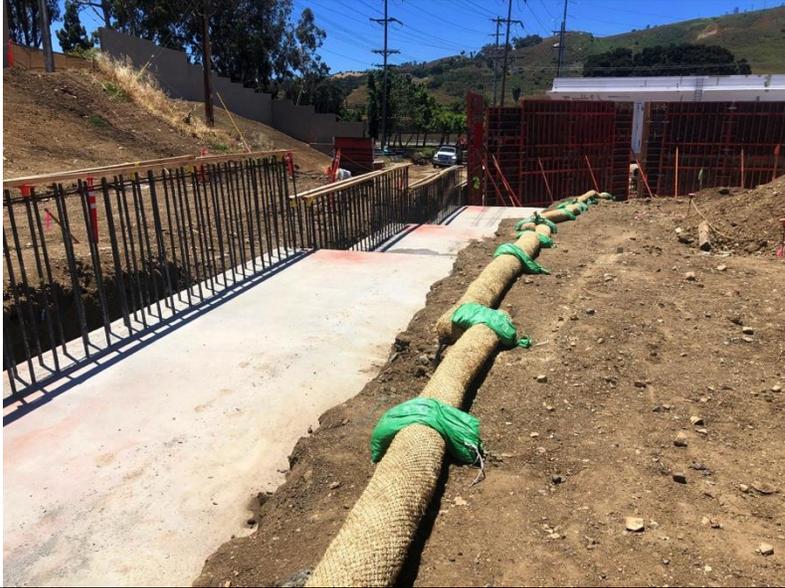
Photo 9 – BMPs added before the latest storm events. Photo facing west.
5/20/19	San Juan Capistrano Substation

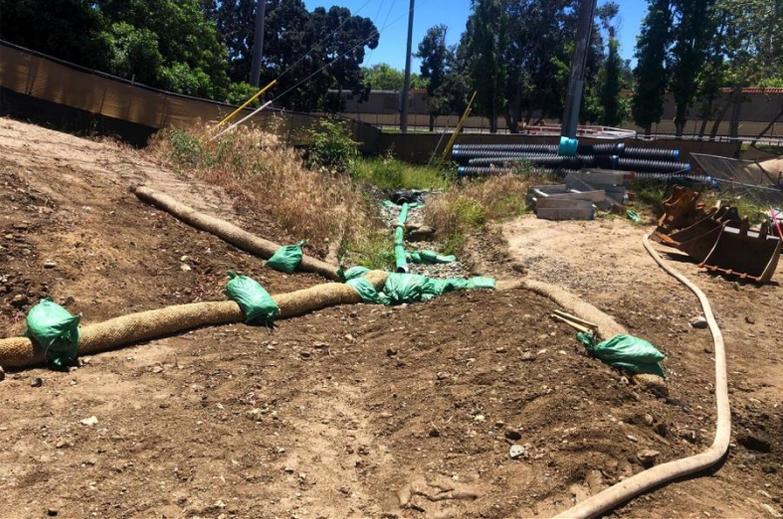
Photo 14 – Upgraded BMPs near the southwestern corner of the San Juan Capistrano Substation site. Photo facing southwest.
